**HOME BUYERS REPORT
PRIOR TO PURCHASE ON:**

**Flat B College House,
Finchley Road,
London,
NW3 5ES**

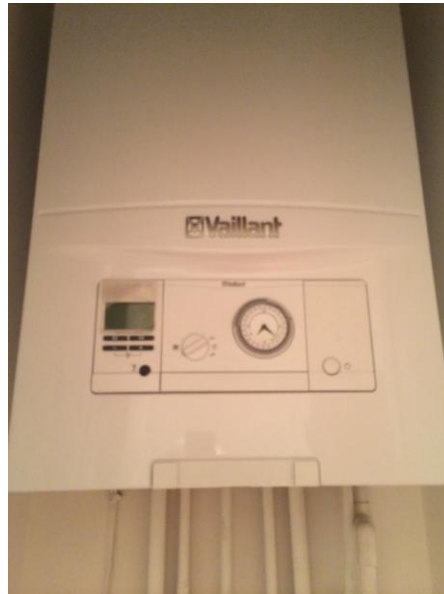
HEATING/HOT WATER – Heating and hot water is provided by an individual Vaillant boiler located in the hall cupboard. There are thermostats on the radiators in each room. The boiler appears to have been recently installed. We would therefore recommend enquiring for a copy of the installation certificate.

New boiler installed, request a copy of the installation certificate.

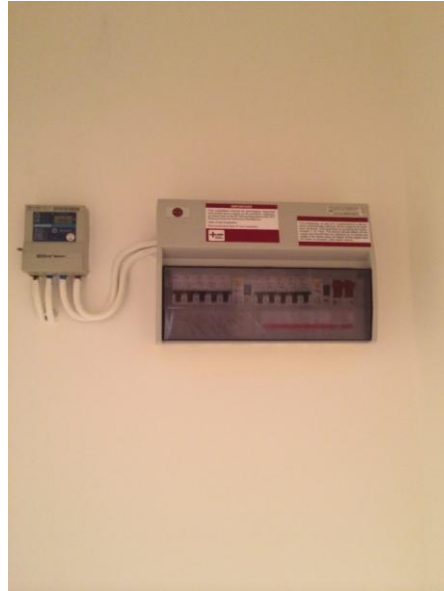
ELECTRIC –The mains electricity supply is located in the storage cupboard in the hallway. The consumer unit is a modern type using MCBs or RCD protection; a current requirement for new properties. We are unaware of when any rewiring works were undertaken all some may have been undertaken during the refurbishment works. We recommend that an NICEIC qualified electrician is employed to undertake a periodic inspection report to determine the condition.

Modern Electrical Consumer unit, request a copy of installation certificate.

Electrical installations in houses are recommended for testing on a 5 yearly basis or at change of ownership.

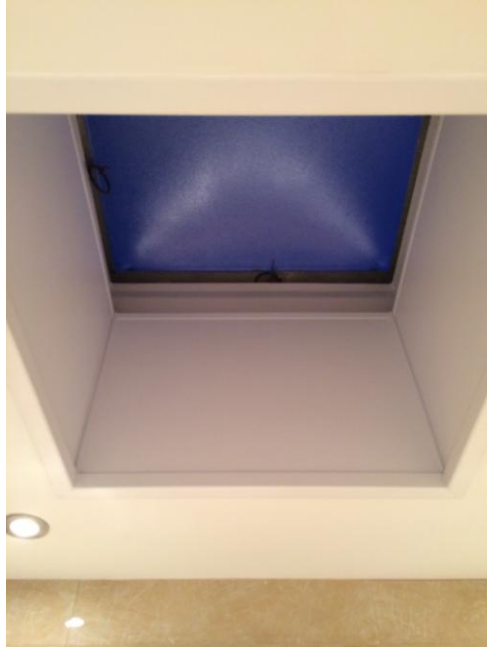
The only form of natural ventilation is via opening the windows onto a busy highway which is both noisy and polluted with car fumes. We therefore suggest as there are roof lights in the bathroom and bedroom a secondary form of natural ventilation is installed to the living room and bedroom. We would recommend a quotation will need to be obtained prior to exchange of contracts.

Limited ventilation in the flat. Enquire if the developer can provide an alternate source of fresh air, via mechanical ventilation to living areas from main roof.
