**ALEXANDER SCOTLAND
CHARTERED SURVEYORS**

**HOME BUYERS REPORT
PRIOR TO PURCHASE ON:**

26A Rozel Road,
Clapham,
London,
SW4 0EZ

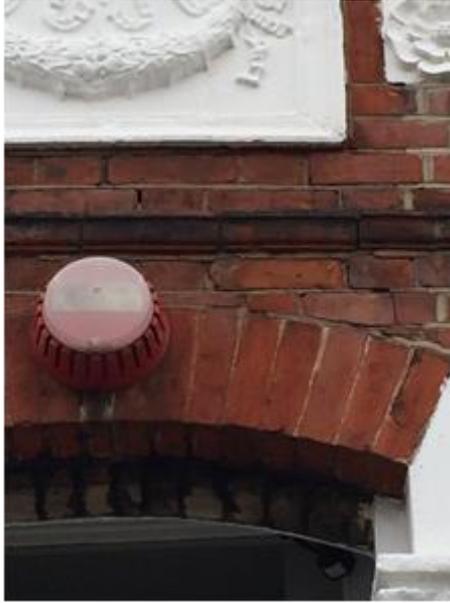
Repair crack to brickwork above communal entrance

Above the entrance porch there are cracks between the bricks due to settlement. We would recommend undertaking a repair to include racking out the mortar between the brickwork and injecting an epoxy resin solution to help arrest further movement. Allow **£850** to undertake these works.

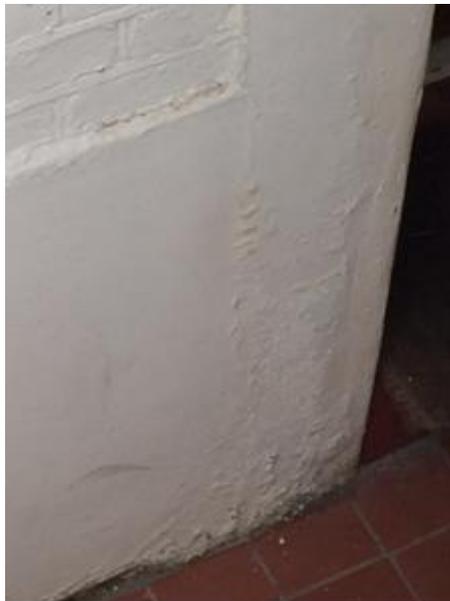
Blown render at basement level requires repair

At basement level on the front elevation, the painted render is in poor condition with some areas which have blown and some cracking. We recommend hacking of the damp affected render and applying a water proof render to match existing and allow decorations. Allow **£900** to undertake these works.

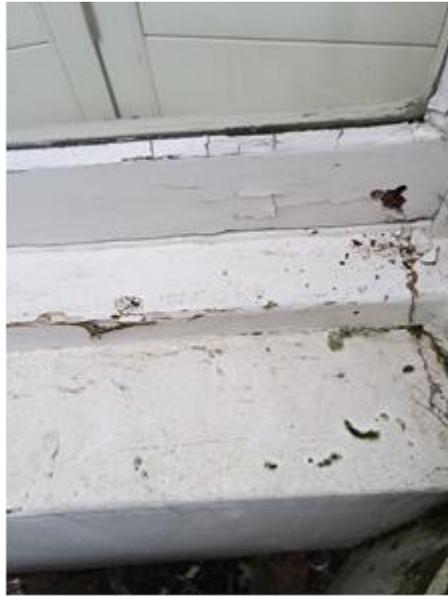
Rotten timber to front bay windows.

The painted timber cills to the front basement bay window are in poor condition with rot and wood filler. We would there recommend repairing the cills by cutting out and piecing in new hard wood timber. Allow **£450** to undertake these works.

The left sash windows to the front basement bay, is rotten and requires replacement. The middle and right sash requires repair. Allow **£900** to undertake these works.

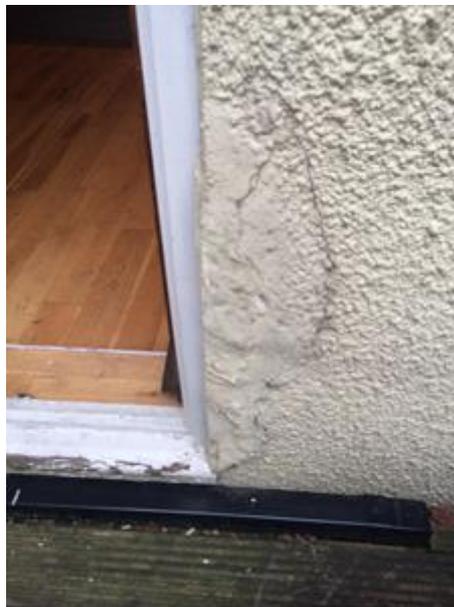
Blown pebble dash render to rear French doors.

There is an area of poorly repaired pebble dash render next to the rear French doors which requires hacking out and repairing. Allow **£250** to undertake these works.

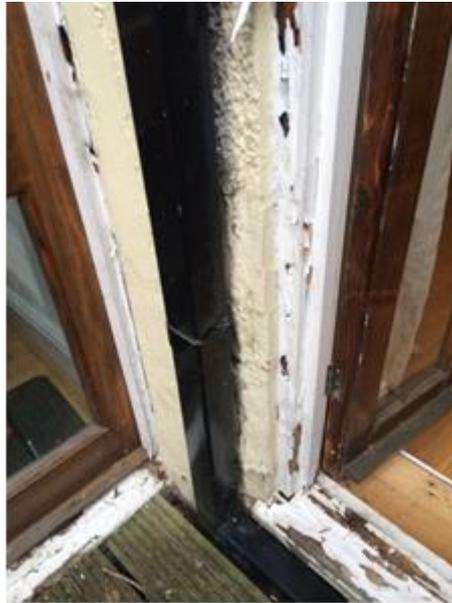
Door frames to kitchen and reception rooms rotten, require replacement

The painted timber frame and threshold to the kitchen door is rotten and requires replacement. Allow **£350** to replace the door and frame to match existing.

The painted timber frame, doors and threshold to the French Doors are rotten and require replacement. Allow **£500** to replace to match existing.

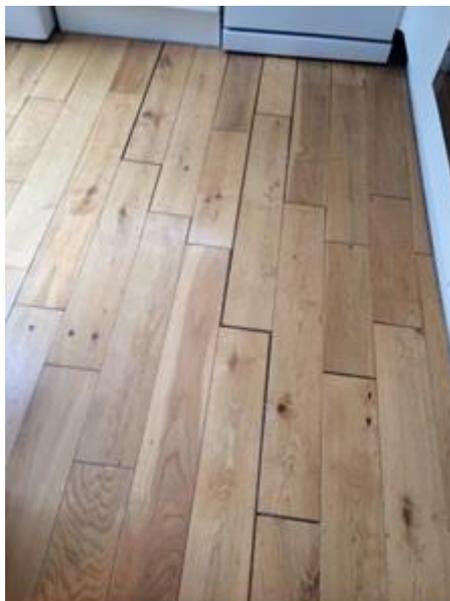
Engineered wooden floor planks require re-fixing.

The engineered wood flooring planks have moved apart in a number of places including the entrance hallway and reception/living room. The flooring planks require to be re-fixed together with epoxy glue. Allow **£500** to undertake these works.

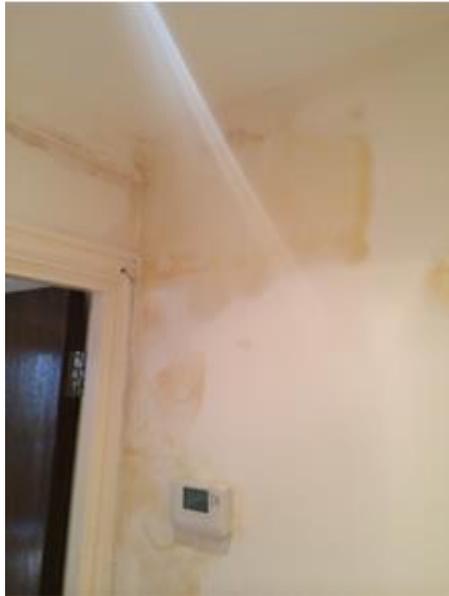
Damp staining to walls above reception doorway appear to be a plumbing issue

As described in the Damp Proof section there are a number of area which require repair as a result of rising damp or leaking internal pipework. Following the damp proofing works and repaired pipework allow **£350** to undertake localised decorations.

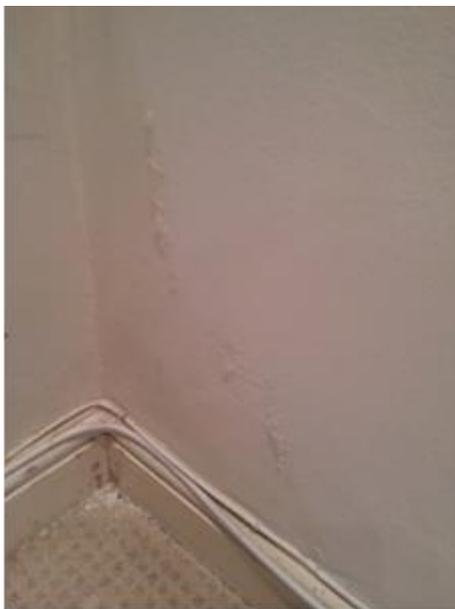
Plaster damage to left of bedroom bay as a result of dampness

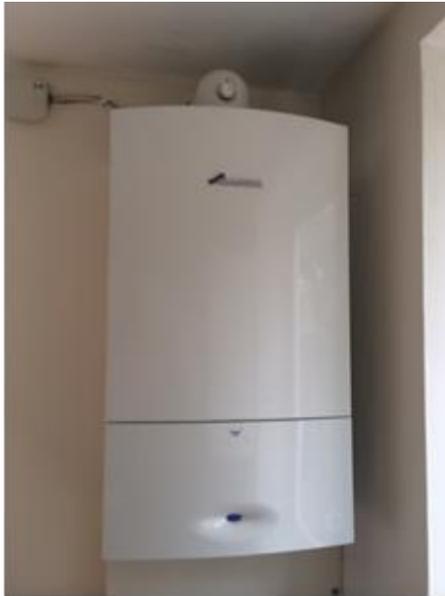
HEATING/HOT WATER – Heating and hot water is provided by an individual Worcester boiler located in the kitchen. There are thermostats on the radiators in each room. The boiler appears to have been recently installed. We would therefore recommend enquiring for a copy of the installation certificate.

Boiler appears recently installed, check installation certificate and service records if any.

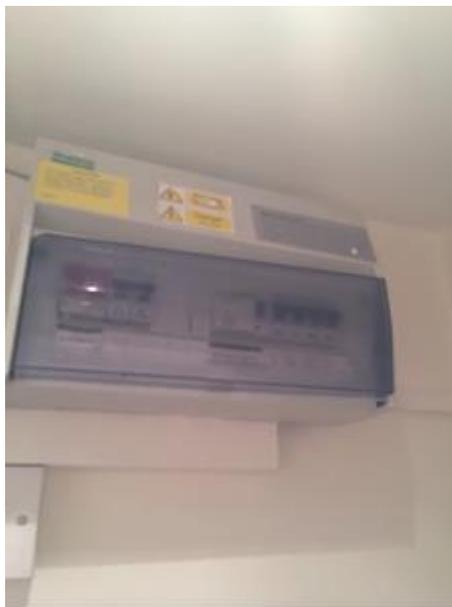
ELECTRIC –The mains electricity supply is located in the storage cupboard in the hallway. The consumer unit is a modern type using MCBs or RCD protection; a current requirement for new properties. We are unaware of when any rewiring works were undertaken all some may have been undertaken during the refurbishment works. We recommend that an NICEIC qualified electrician is employed to undertake a periodic inspection report to determine the condition.

Modern electrical consumer unit, although wiring should be tested.
