ALEXANDER SCOTLAND
CHARTERED SURVEYORS

SCHEDULE OF CONDITION

184 FORDWYCH ROAD,

NW2 3NX

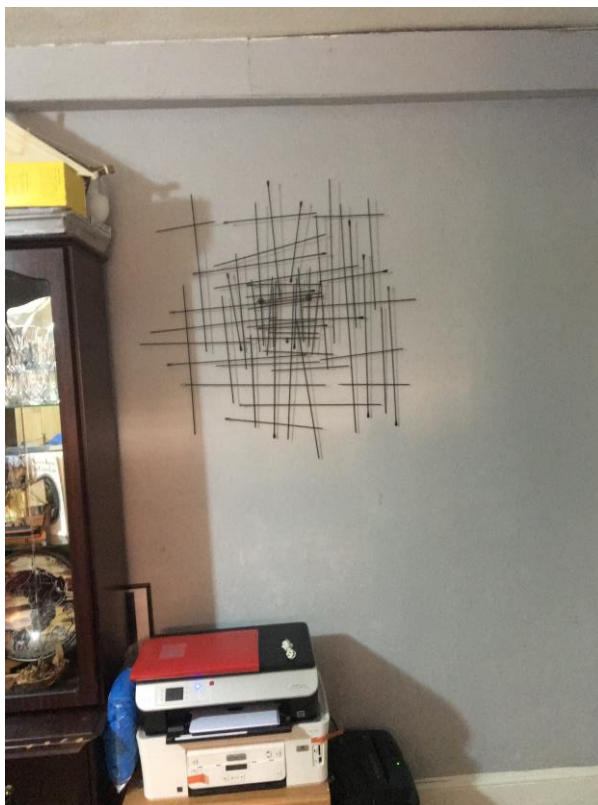
Slightly blotchy paint but no obvious cracks to ground floor rear reception

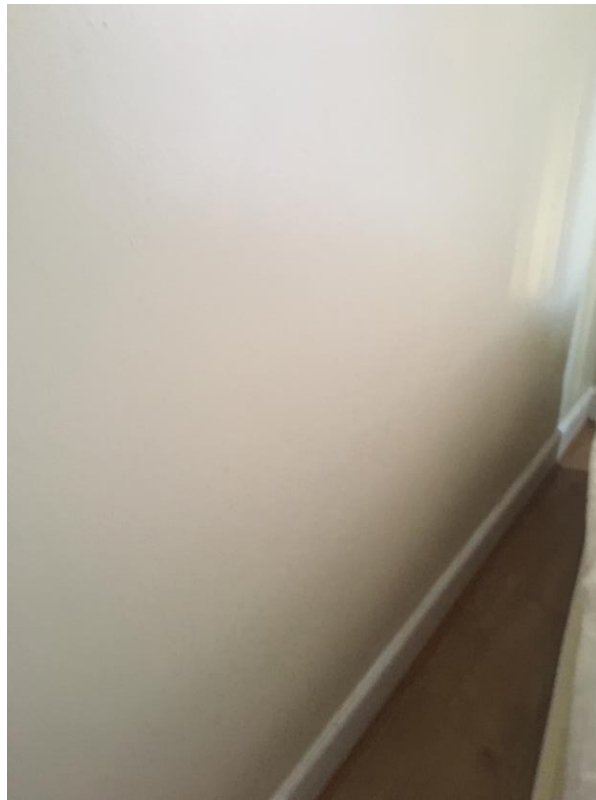
Even plaster finish no obvious cracks behind bed in first floor bedroom

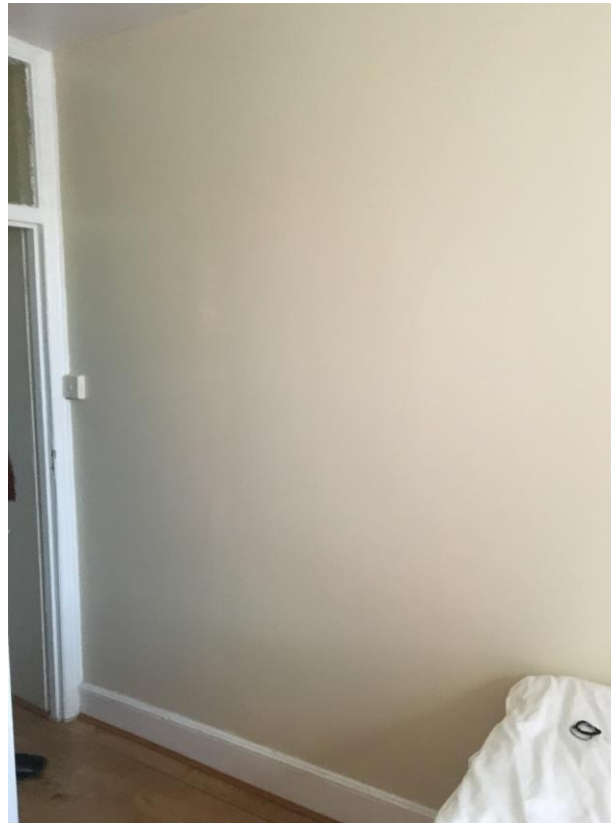
Wall to rear bedroom appears in fair condition

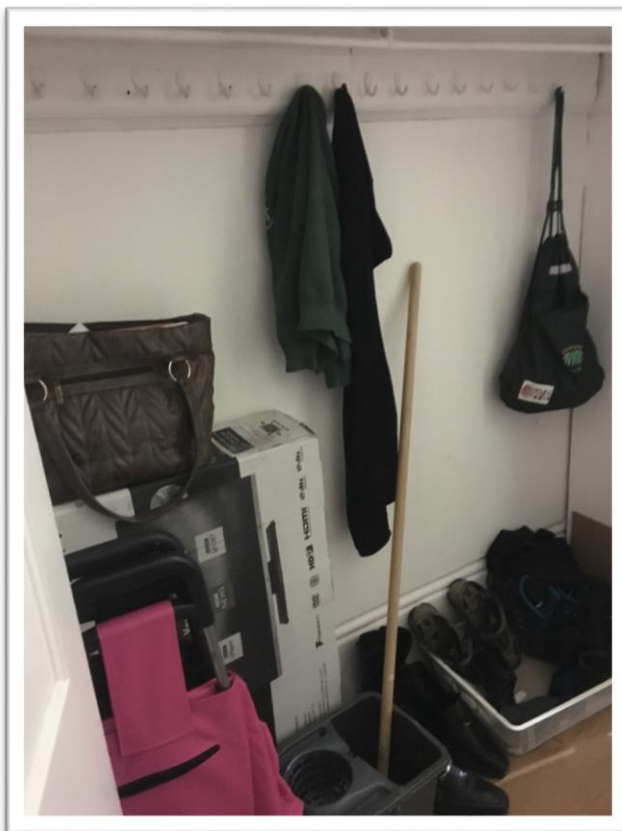
Inside Wardrobe on First Floor Landing

LOCATION	ELEMENT	DISCRIPTION	CONDITION	COST (£)
First Floor Flat				
Hallway/Landing				
	Party Wall	Painted timber wardrobe with painted lining paper to wall with numerous coat hooks. Hot water tank	The cupboard is full of the owner's belongings, but where the wall is obvious appears to be in good order with no obvious cracks or blown plaster.	N/A
First Floor				
Front Bathroom	Party Wall	Ceramic tiles approximately 1.8m above the floor level with painted woodchip lining paper above and a period plaster coving.	The ceramic tiles appear to be generally unevenly laid but there don't appear to be any obvious cracked or loose tiles. There is an area of bulging plaster below the plaster coving to the left side of the party wall, next to the external wall.	N/A

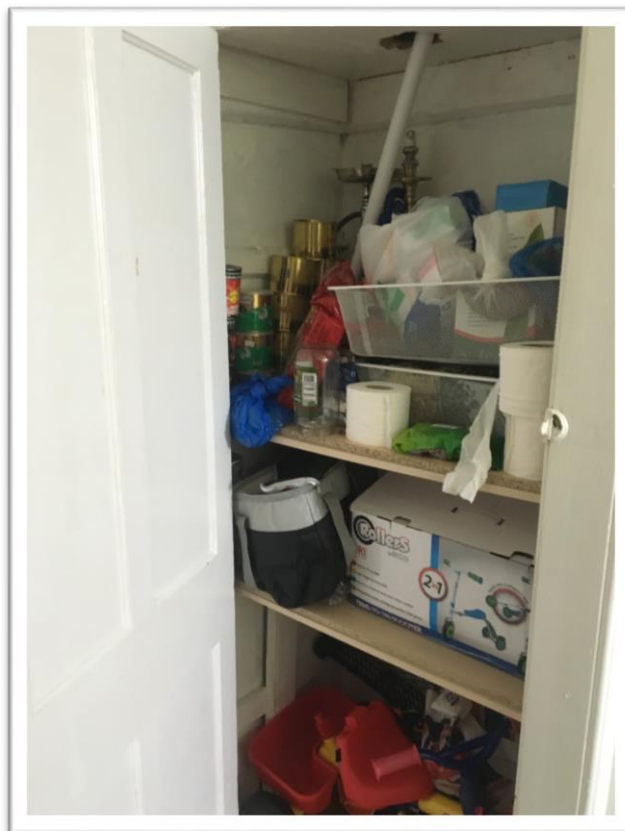
Limited View inside Small Wardrobe with water tank above

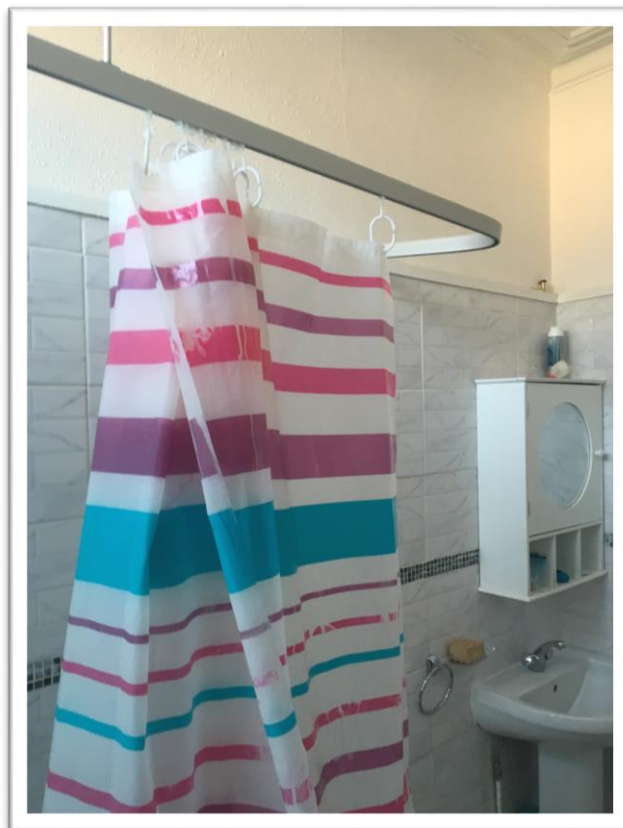
Bathroom wall on First Floor appears in fair condition

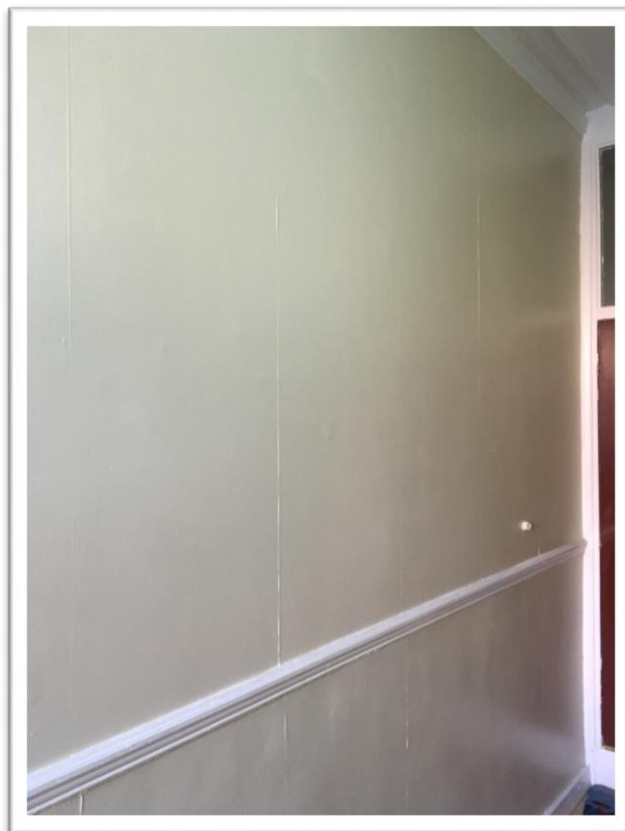
Communal Entrance Hallway on Ground Floor

LOCATION	ELEMENT	DISCRIPTION	CONDITION	COST (£)
INTERNAL				
Communal Entrance Hallway	Party Wall	Painted Lining Paper with painted timber dado rail painted timber skirting.	The edges of the lining paper have lifted slightly up to about 1 - to 10mm. There is no evidence of any obvious cracks. The surface of the lining paper appears un-even with some minor bulges approx. 20-50mm.	N/A
Ground Floor Flat				
TV Room	Party Wall	Painted Wood Chip Lining Paper with painted skirting. A large central floor cabinet and floor units. There is a painted timber conduit to the left side of the party wall.	The decorated wall surfaces appear to be slightly patchy with a number of nail marks and minor areas of slightly lifting lining paper. There is no evidence of any obvious cracks.	N/A
First Floor Flat				
Rear Bedroom	Party Wall	Painted Lining Paper with painted timber skirting.	The decorated surface appears even with no obvious areas of blown plaster or cracking. There is lump of plaster approx. 1.5m from the left wall of the bedroom.	N/A

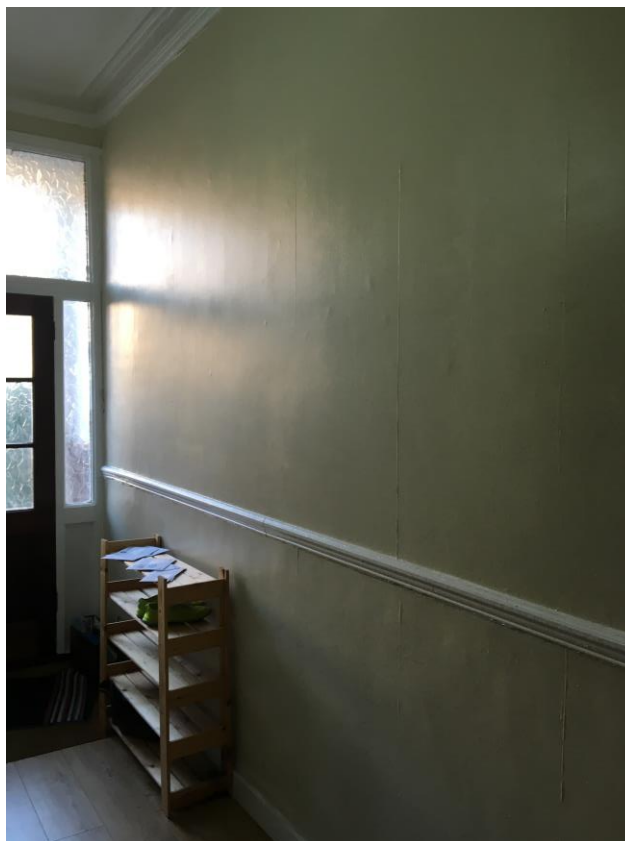
Communal Entrance Hall in fair condition with no obvious cracks
