**ALEXANDER SCOTLAND
CHARTERED SURVEYORS**

**GENERAL BUILDING SURVEY
PRIOR TO PURCHASE ON:**

Harefield Lodge,
331 Harlesden Road,
Willesden,
London
NW10 3RX

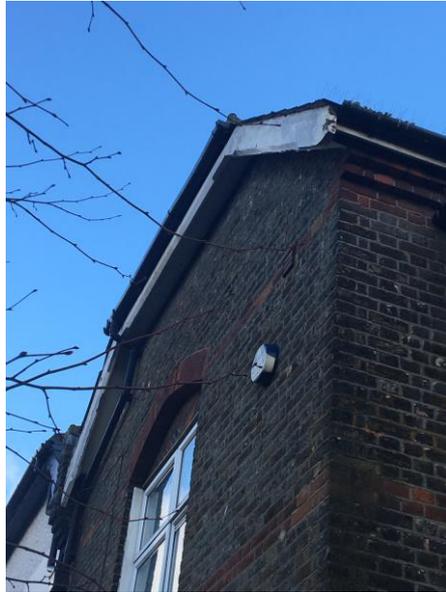
There a number of areas of loose paint, exposed wood and minor areas of rot to the front decorative timber barge boards to the cropped gable and painted timber fascia boards. We suggest undertaking repairs to the timber work to prevent further decay and decoration works.

Loose paint exposed timber and rot to the front decorative barge board

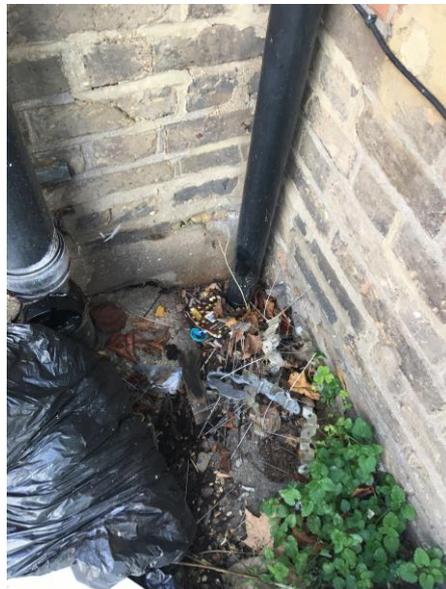
Blocked gullies below rainwater downpipes

Both front gullies below the rainwater pipes are blocked and require water jetting through to clear. Allow **£150** (1) to undertake these works.

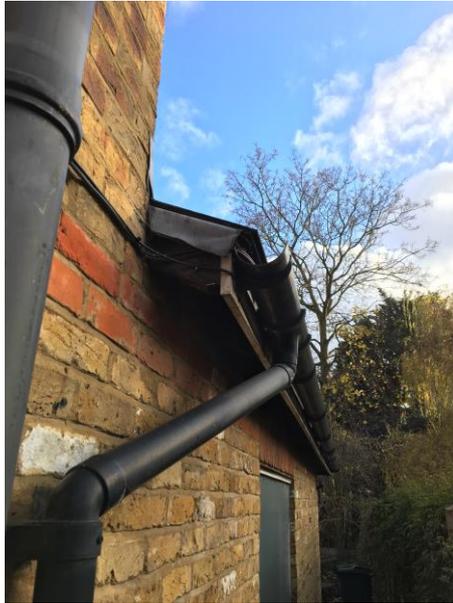
Missing end cap to gutter on single storey extension

The end cap to the rear single storey extension is missing and requires renewal. Allow **£100** (1) to replace and make good.

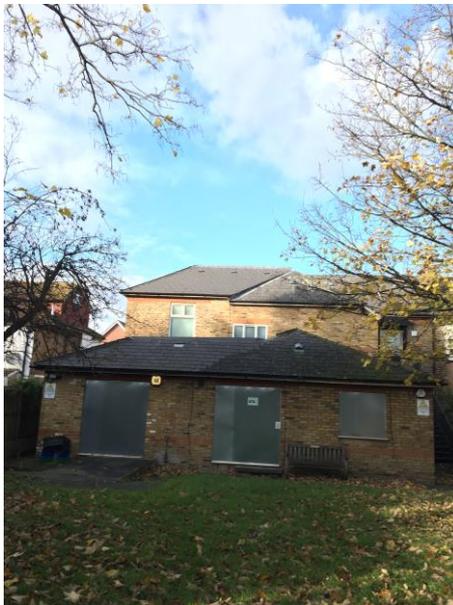
Limited access to window openings as boarded over

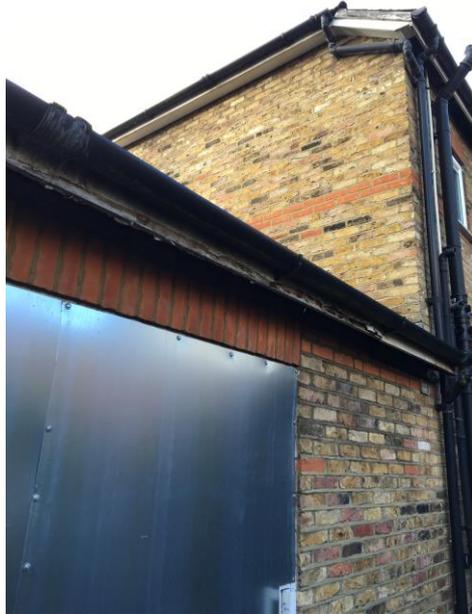
There is loose paint and exposed wood to the right side of the rear single storey extension. The timberwork appears in good condition, but will require decoration works.

Loose paint and exposed wood to fascia board, but timber appears solid

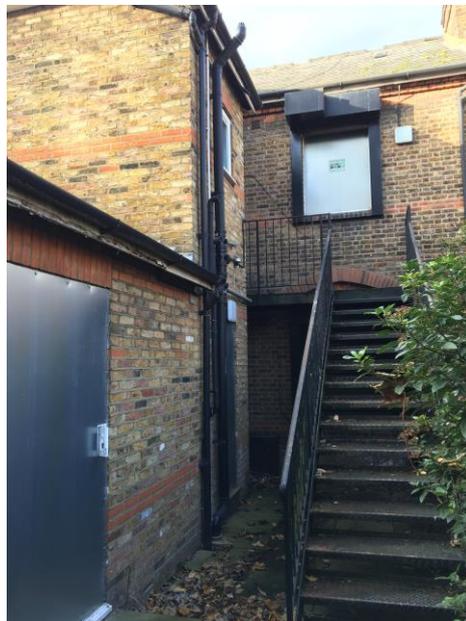
There are a number of areas of loose paint exposed steel and small areas of corrosion. The staircase appears solidly constructed with no significant defects to report.

Rear metal fire escape stairs appears solidly constructed

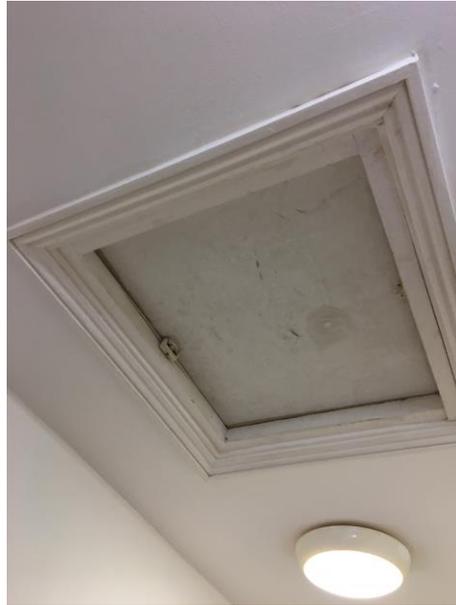
The loft hatches to the main roof and rear roof void are currently locked so we are unable to confirm the condition of the main roof joists.

Locked loft hatch restricts access into the roof void

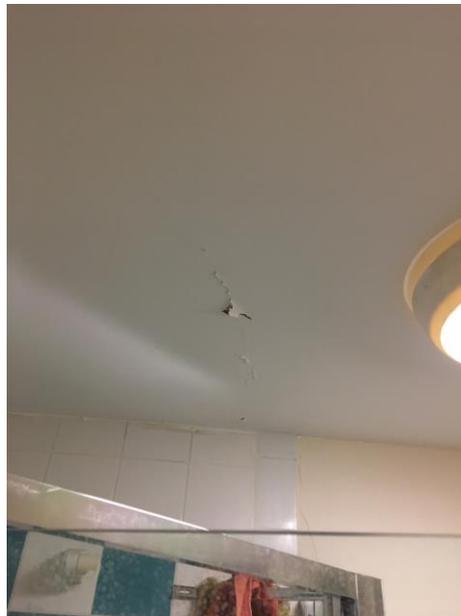
There is loose plaster due to condensation in the en-suite bathroom above the shower to room 8, at the front building on the first floor. This is a minor defect which requires localised repair and decoration.

Loose paint due to condensation in en-suite bathroom

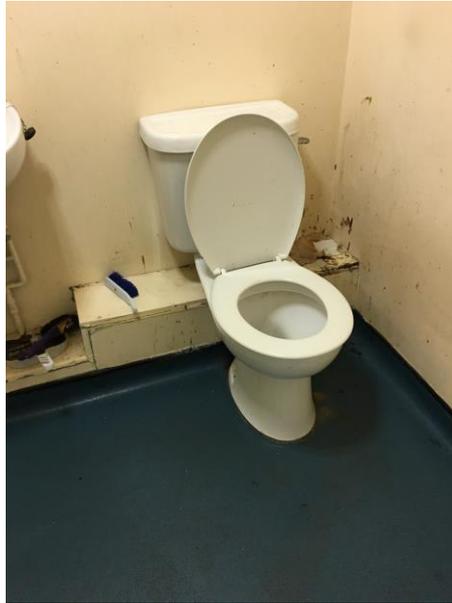
The painted timber boxing to the waste pipes behind the WC in Room 5 & 6 is rotten due to plumbing leaks, so we suggest repairing the leaks and replacing the boxing. Allow **£300** (1) to undertake these works.

Defective boxing behind WC's in en-suites to Room 5 & 6

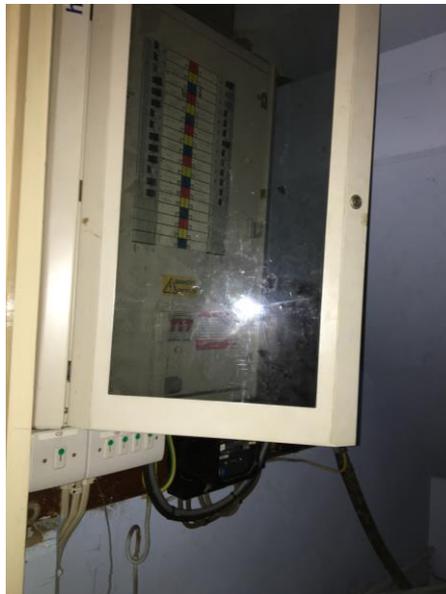
ELECTRIC – The electricity supply is distributed through a modern electrical consumer unit with MCB & RCD protection. The electrical installation generally appears to be in fairly good order with numerous modern switches and sockets, however no tests have been undertaken on the installation.

Modern Electrical Consumer Unit.

Generally electrical installations are recommended for testing on a 5 yearly basis or at change of ownership. As a minimum requirement we recommend that the system be inspected and tested by a NICEIC qualified electrician and a periodic inspection report obtained with all subsequent recommendations duly undertaken.

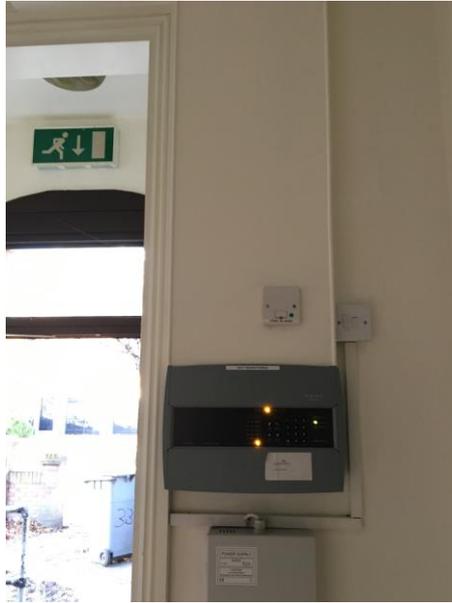
Fire Alarm Panel

There are fire doors throughout the property, with smoke detectors and a Fire Alarm with the main panel in the entrance hallway. We suggest obtaining the latest Fire Certificate to confirm the system is fully functioning.
